LETTER REPORT  
FOR  
MICHCON "H"  
DETROIT, WAYNE COUNTY, MICHIGAN  
TDD S05-9801-020  
PAN 8J2001SDXX

March 30, 1998

Re: MichCon "H"  
Detroit, Wayne County, Michigan  
TDD S05-9801-020  
PAN 8J2001SIXX

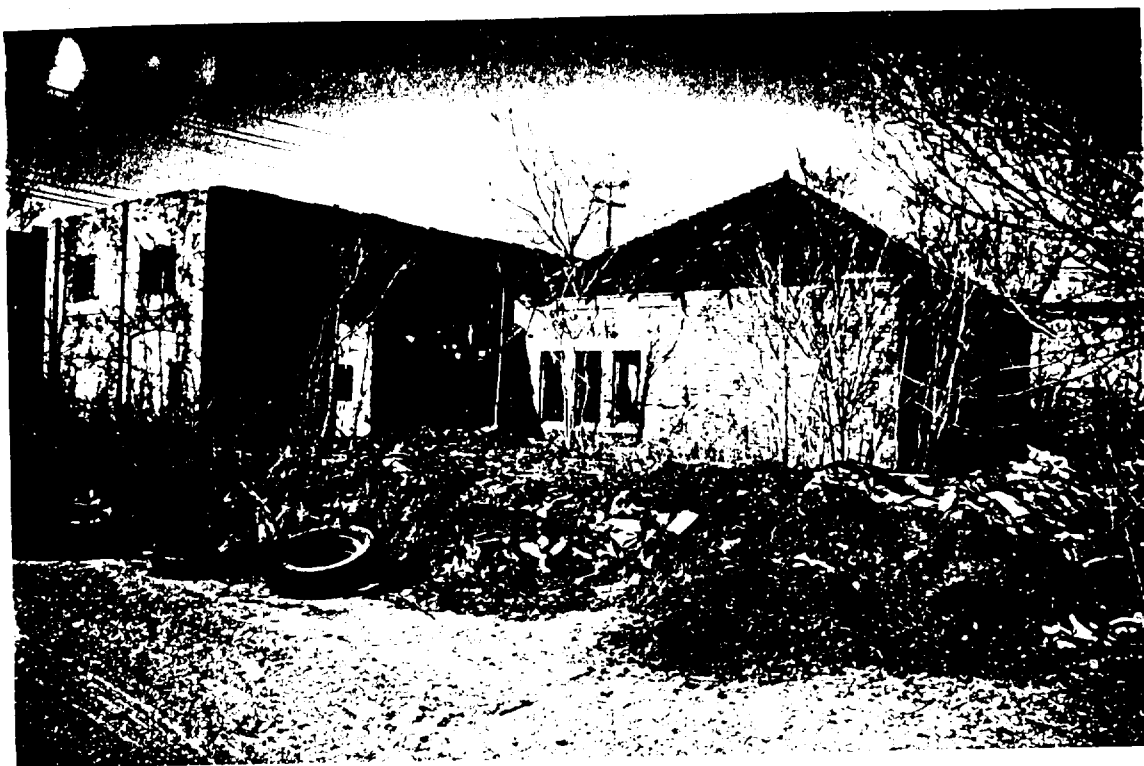
**Site:** MichCon "H"  
**Photo No:** 3 (R2F5)  
**Direction:** Northwest  
**Camera:** Minolta 35mm  
**Photographer:** Mark Ramaly

**Date:** 2/3/98  
**Subject:** Southeastern side of Building 1. Note roofing debris and tires littering the site.

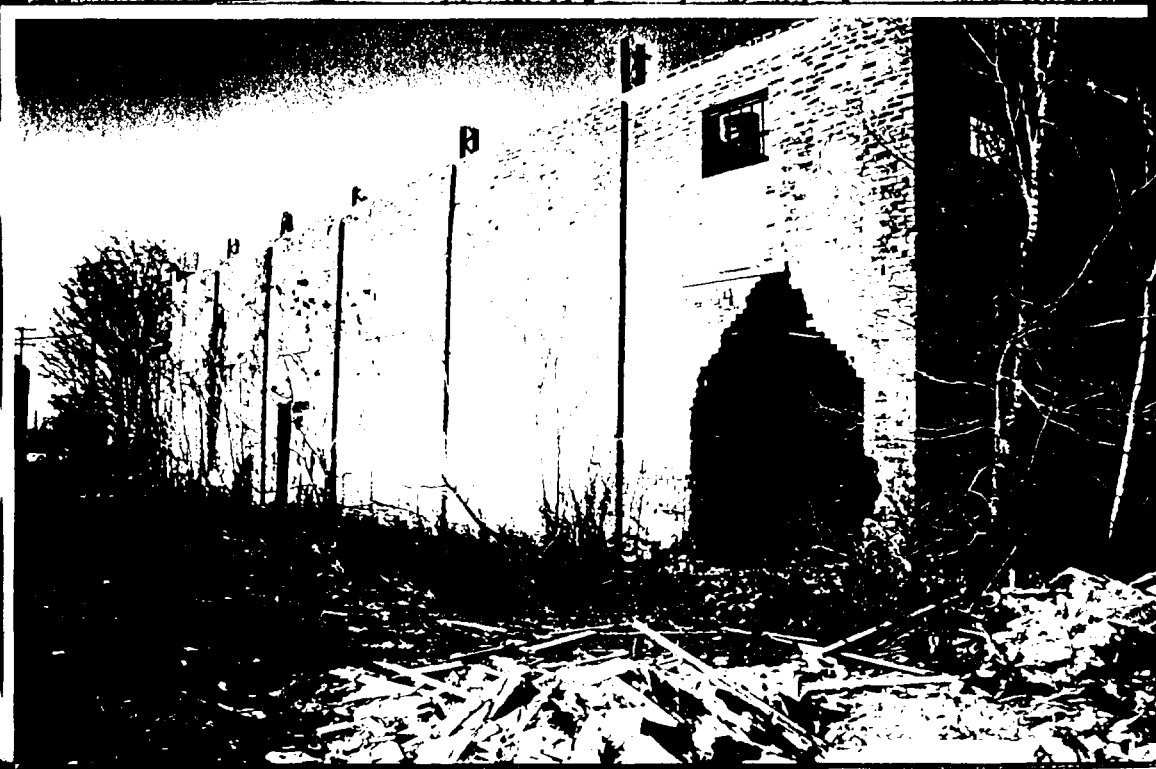
Site: MichCon "H"  
Photo No: 6 (R2F2)  
Direction: Northwest  
Camera: Minolta 35mm  
Photographer: Mark Ramaly

Date: 2/3/98  
Subject: Eastern portion of Building 2. Note construction debris scattered around the building.

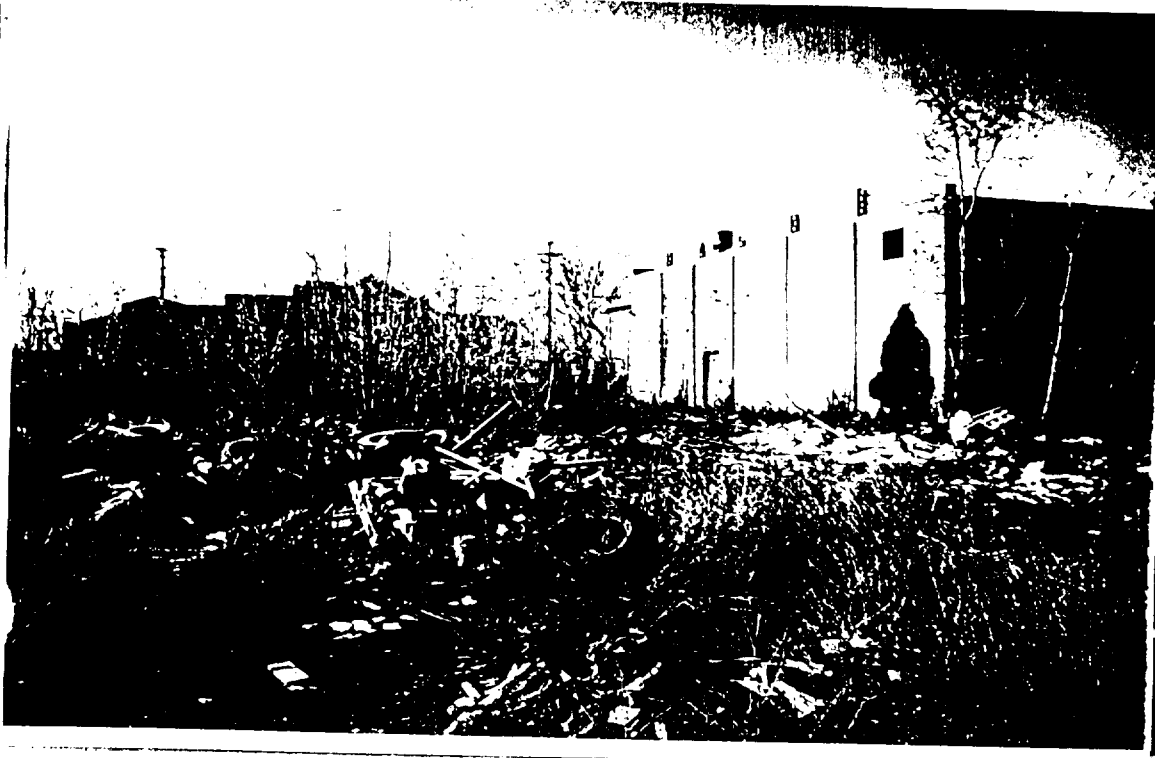
**Site:** MichCon "H"  
**Photo No:** 7 (R1F23)  
**Direction:** West  
**Camera:** Minolta 35mm  
**Photographer:** Mark Ramaly

**Date:** 2/3/98  
**Subject:** Southwestern side of the site and Building 2.  
 Note tires, roofing debris, and miscellaneous debris  
 littering the site.

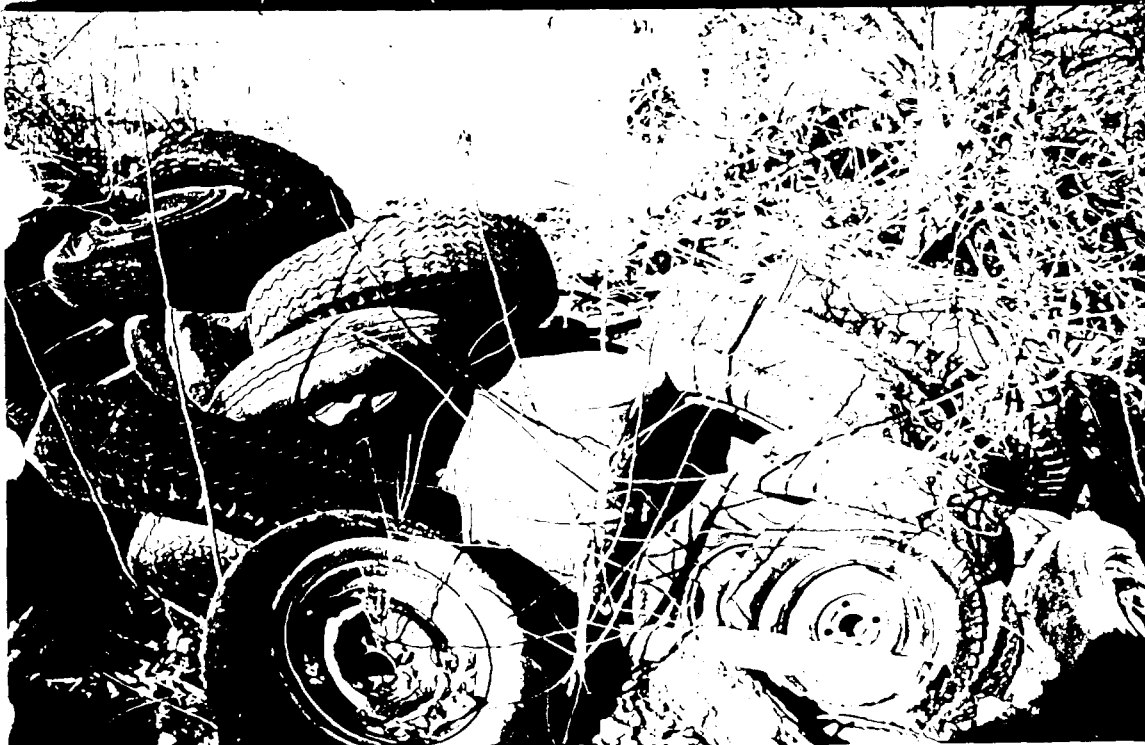
Site: MichCon "H"  
Photo No: 20 (R1F8)  
Direction: Northwest  
Camera: Minolta 35mm  
Photographer: Mark Ramaly

Date: 2/3/98  
Subject: Rusty drum within a pile of tires located southwest of Pile 2.

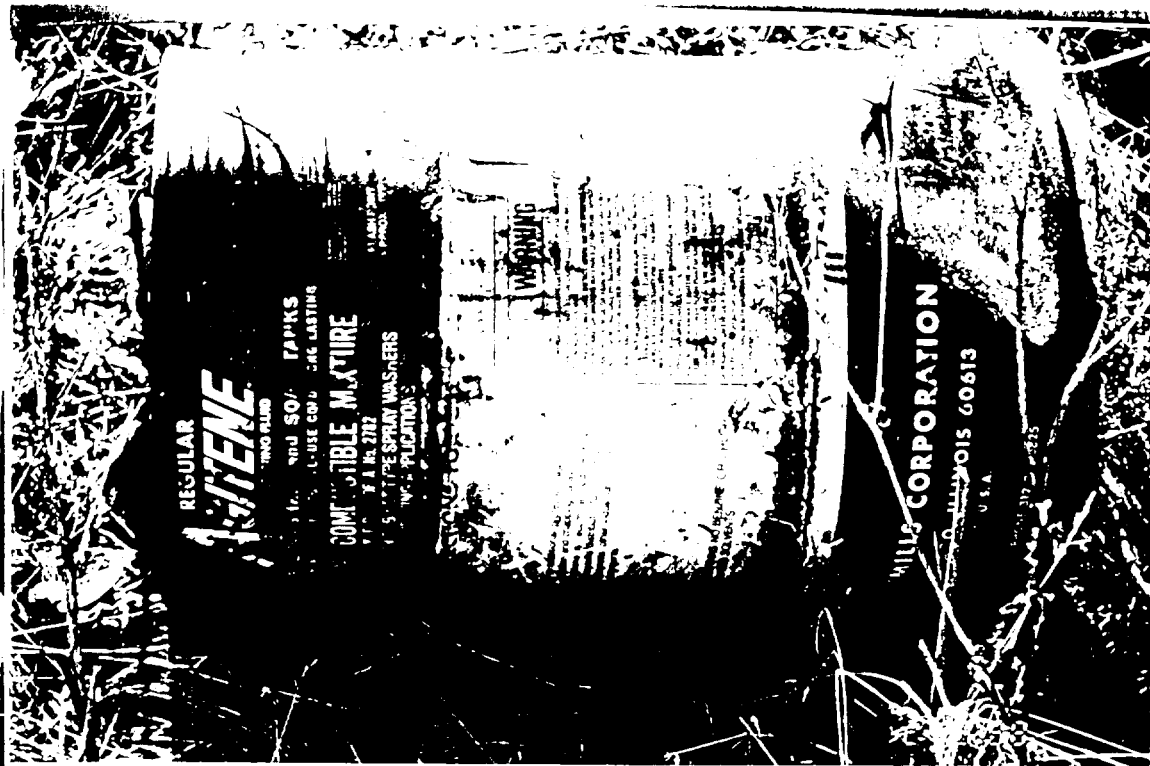
Photo No: 27 (R1F14)

Subject: Drum marked "Agitene" and "Combustible Mixture" located at the eastern corner of the site.

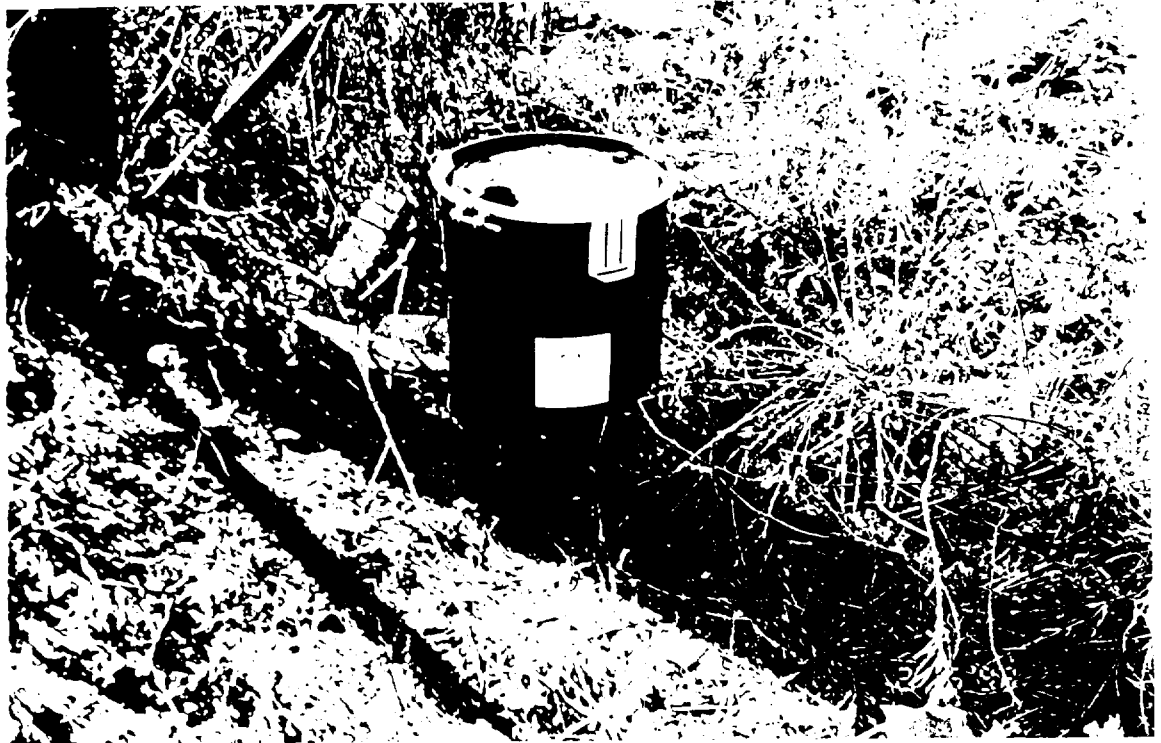
**Site:** MichCon "H"  
**Photo No:** 33 (R3F5)  
**Direction:** Southwest  
**Camera:** Olympus 35mm  
**Photographer:** Mark Ramaly

**Date:** 2/6/98  
**Subject:** Lined 30-gallon steel drum used to overpack capacitors.
